WADC TECHNICAL REPORT 52-228

**COMPLETE TYPE TEST OF AEROPRODUCTS TWO-BLADED PROPELLER,
MODEL NO. A422-69 (Whirl Test No. 2273)**

**ROBERT R. STEPHENSON, 2D LT, USAF
PROPELLER LABORATORY**

SEPTEMBER 1952

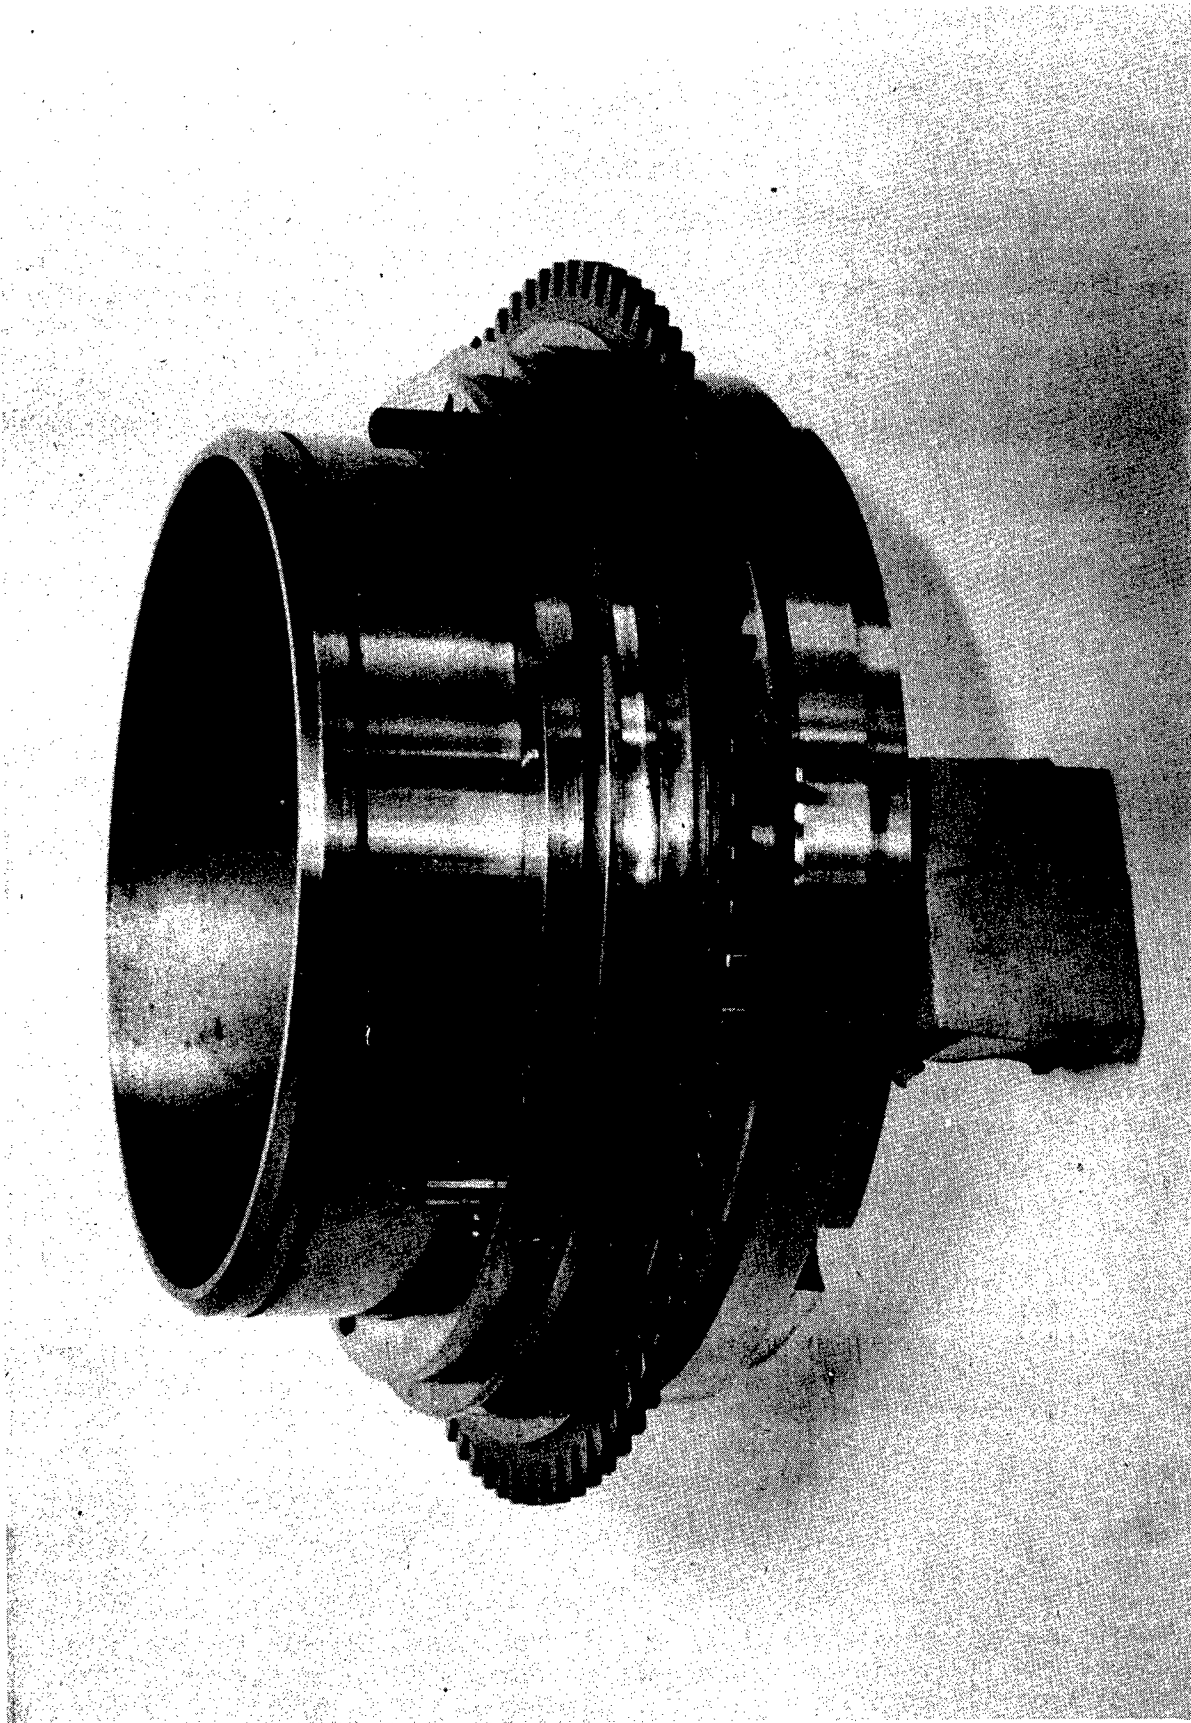
After ten hours of operation, difficulty was experienced in the movement of the control arm to effect a change in control conditions. Investigation revealed that the threads in the control ring had worn, causing cocking of the bronze control ring on the pump power gear assembly. An attempt was made to prevent thread wear by using two bronze control rings held apart by springs as shown in Figure 15. It was intended that the springs would keep the control ring pressed against one side of the threads and thus prevent excessive wear and take up backlash of the motion. However, after 24:30 hours of operation, the rivets in the spring-loaded control ring failed as shown in Figure 16. A control ring of nitriding steel was next used in the regulator and satisfactorily completed the type test.

Fig 15 - Pump Power Gear Assembly, Showing
Spring Loaded Regulator Control Ring

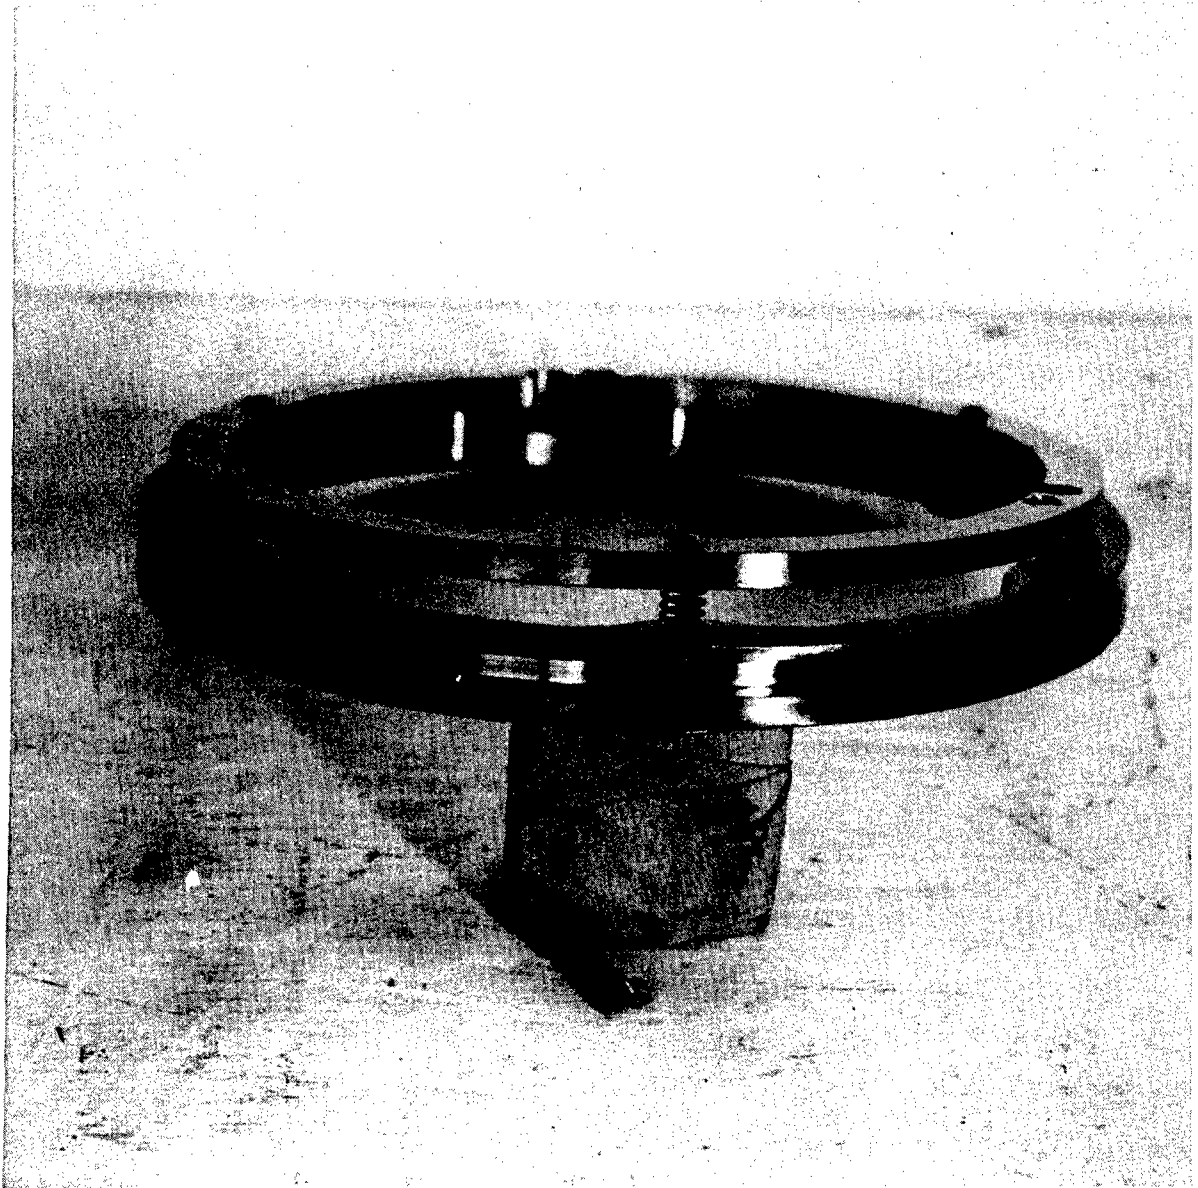
Fig 16 - Control Ring with Broken Rivet After 26:30
Hours on R-1300-1 Engine. Aeroproducts Model
A422-69 Propeller.

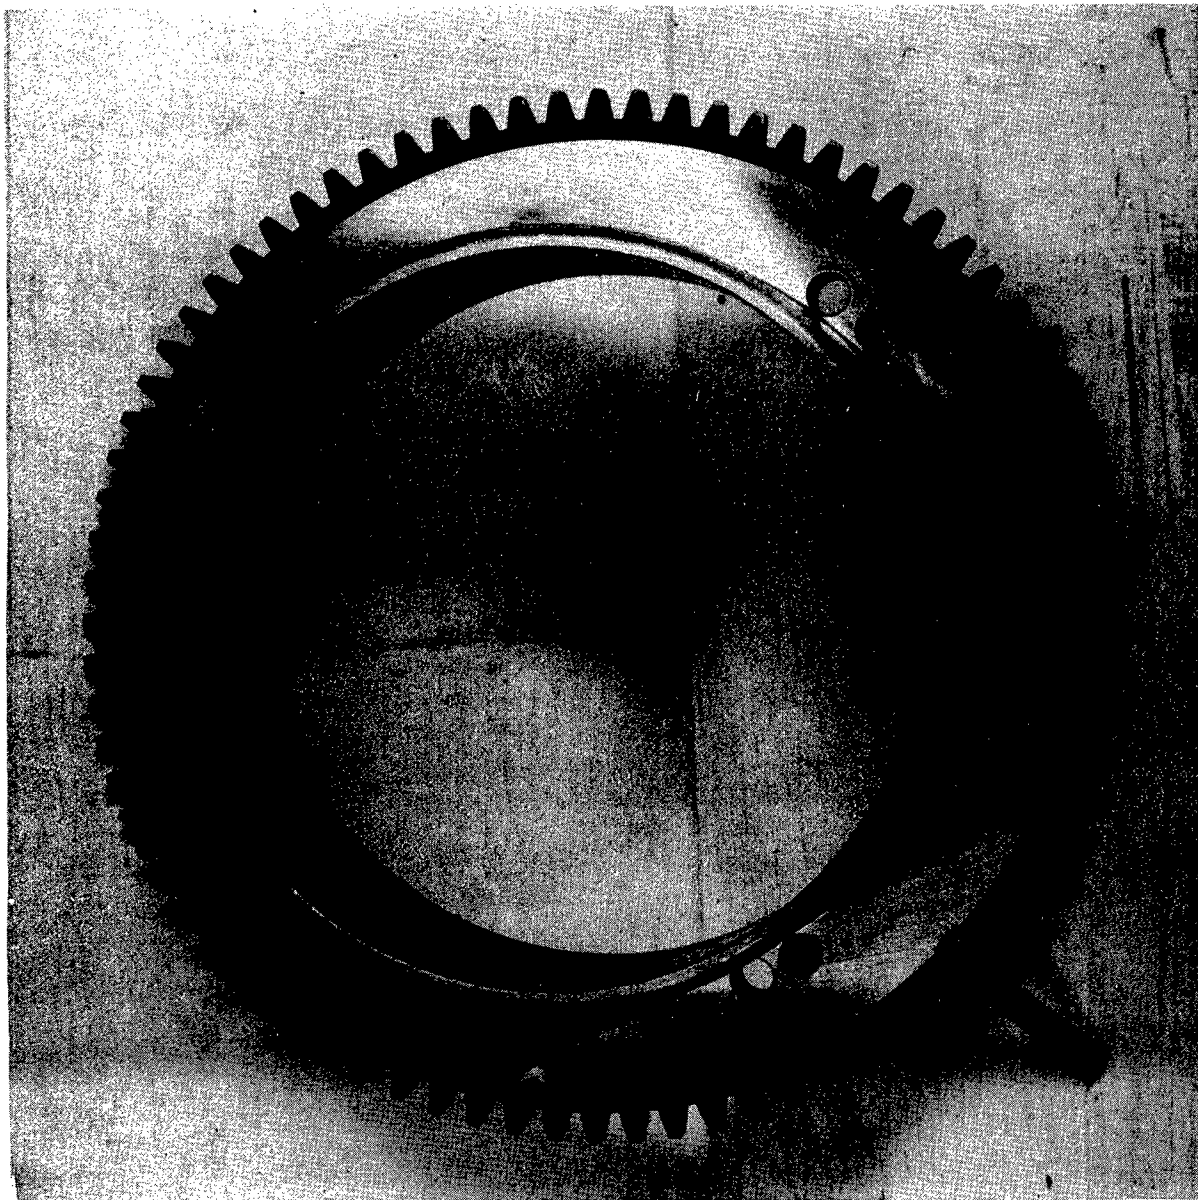
At the first 25 hour inspection, it was found that the control ring guide pin had broken at the base as shown in Figure 17. This guide pin was replaced with a larger diameter pin which was found satisfactory at the end of the 100 hour endurance test plus an additional 25 hour penalty run due to the failed guide pin.

Fig 17 - Broken Guide Pin and Pump Power
From A422-69 Propeller Regulator

Two changes were made in the propeller during testing, (1) the bronze control ring was replaced by a control ring of nitriding steel, and (2) the guide pin for the control ring was replaced with a guide pin of larger diameter. Both of these changed parts satisfactorily completed 100 hours of endurance operation.

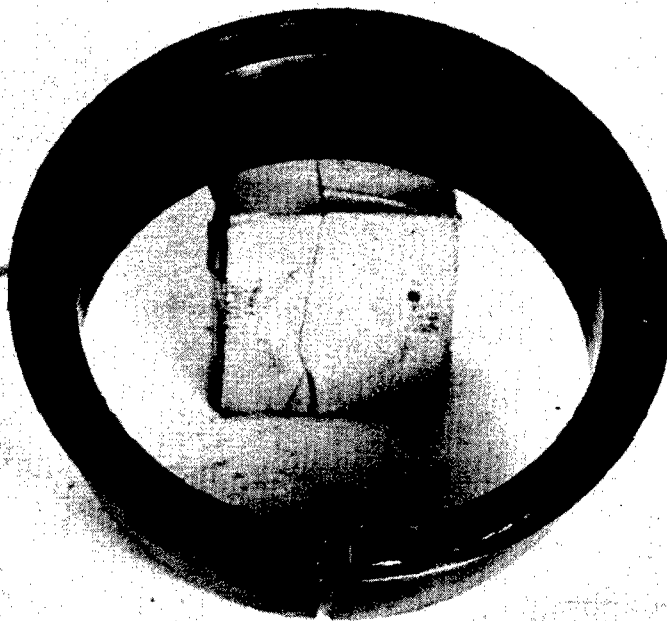
After the first eight hours of operation, excessive galling of the rear cone and cone seat was noticed as shown in Figures 18, 19, and 20. The propeller was removed, the cone seat lapped, a new cone installed, and the propeller was replaced with the torque measured at 800 ft-lb. on the propeller shaft retaining nut. It was found by repeated tests, however, that the necessary torque to prevent galling was 1200 ft-lb. After the retaining nut was tightened to 1200 ft-lb., no galling of the cones was encountered.

Fig 18 - Rear Face of Rear Cone. A422-69 Propeller On
R-1300-1 Engine After 26:30 Hours of Operation

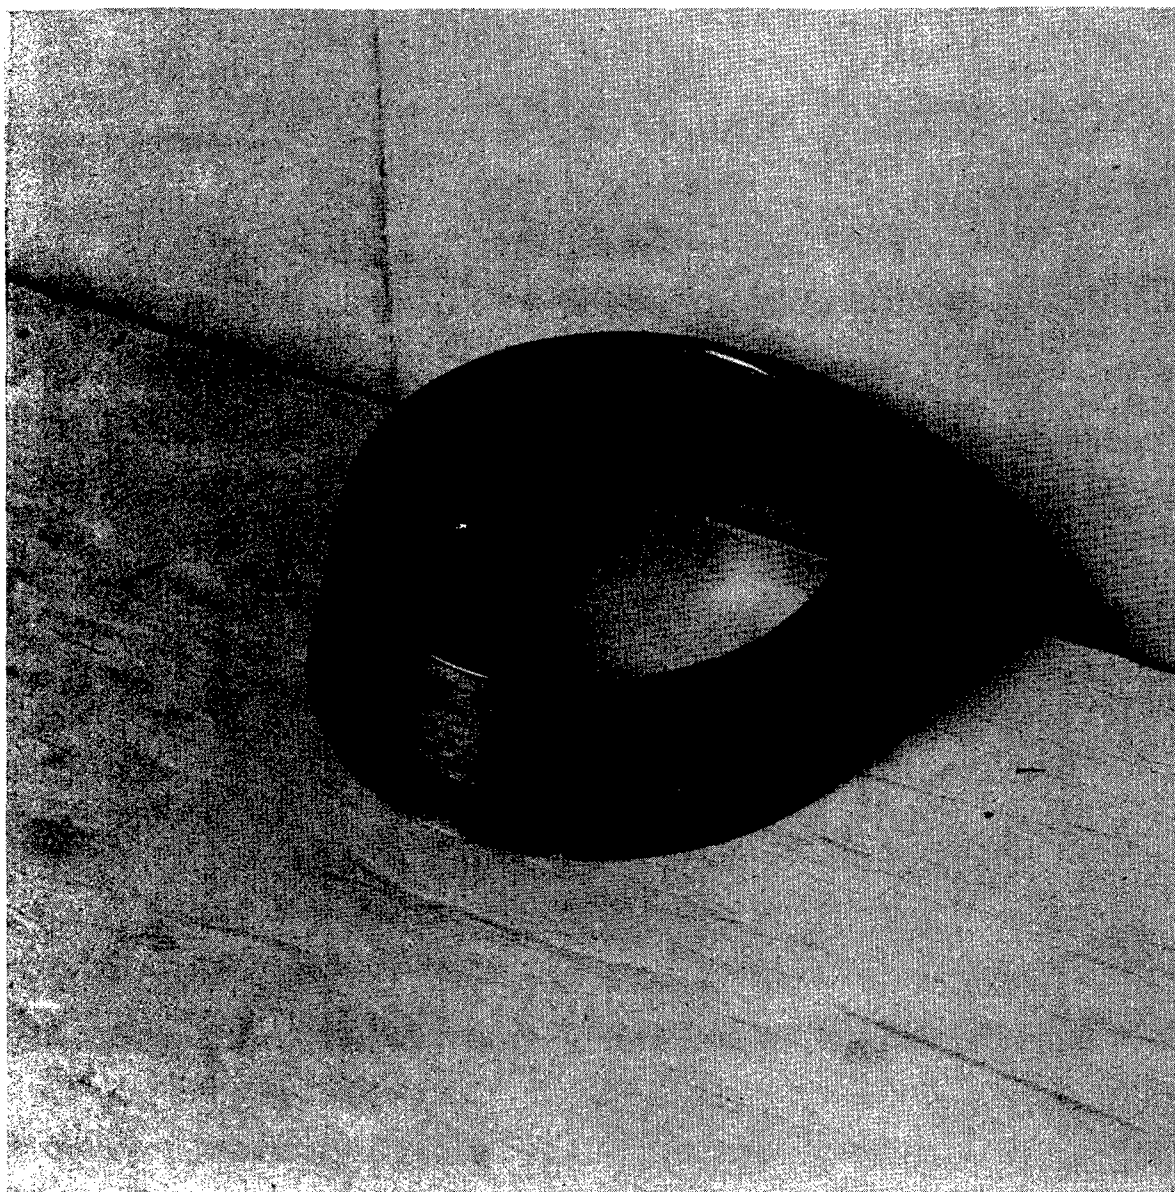
Fig 19 - Tapered Face of Rear Cone. A422-69 Propeller on
R-1300-1 Engine After 26:30 Hours of Operation

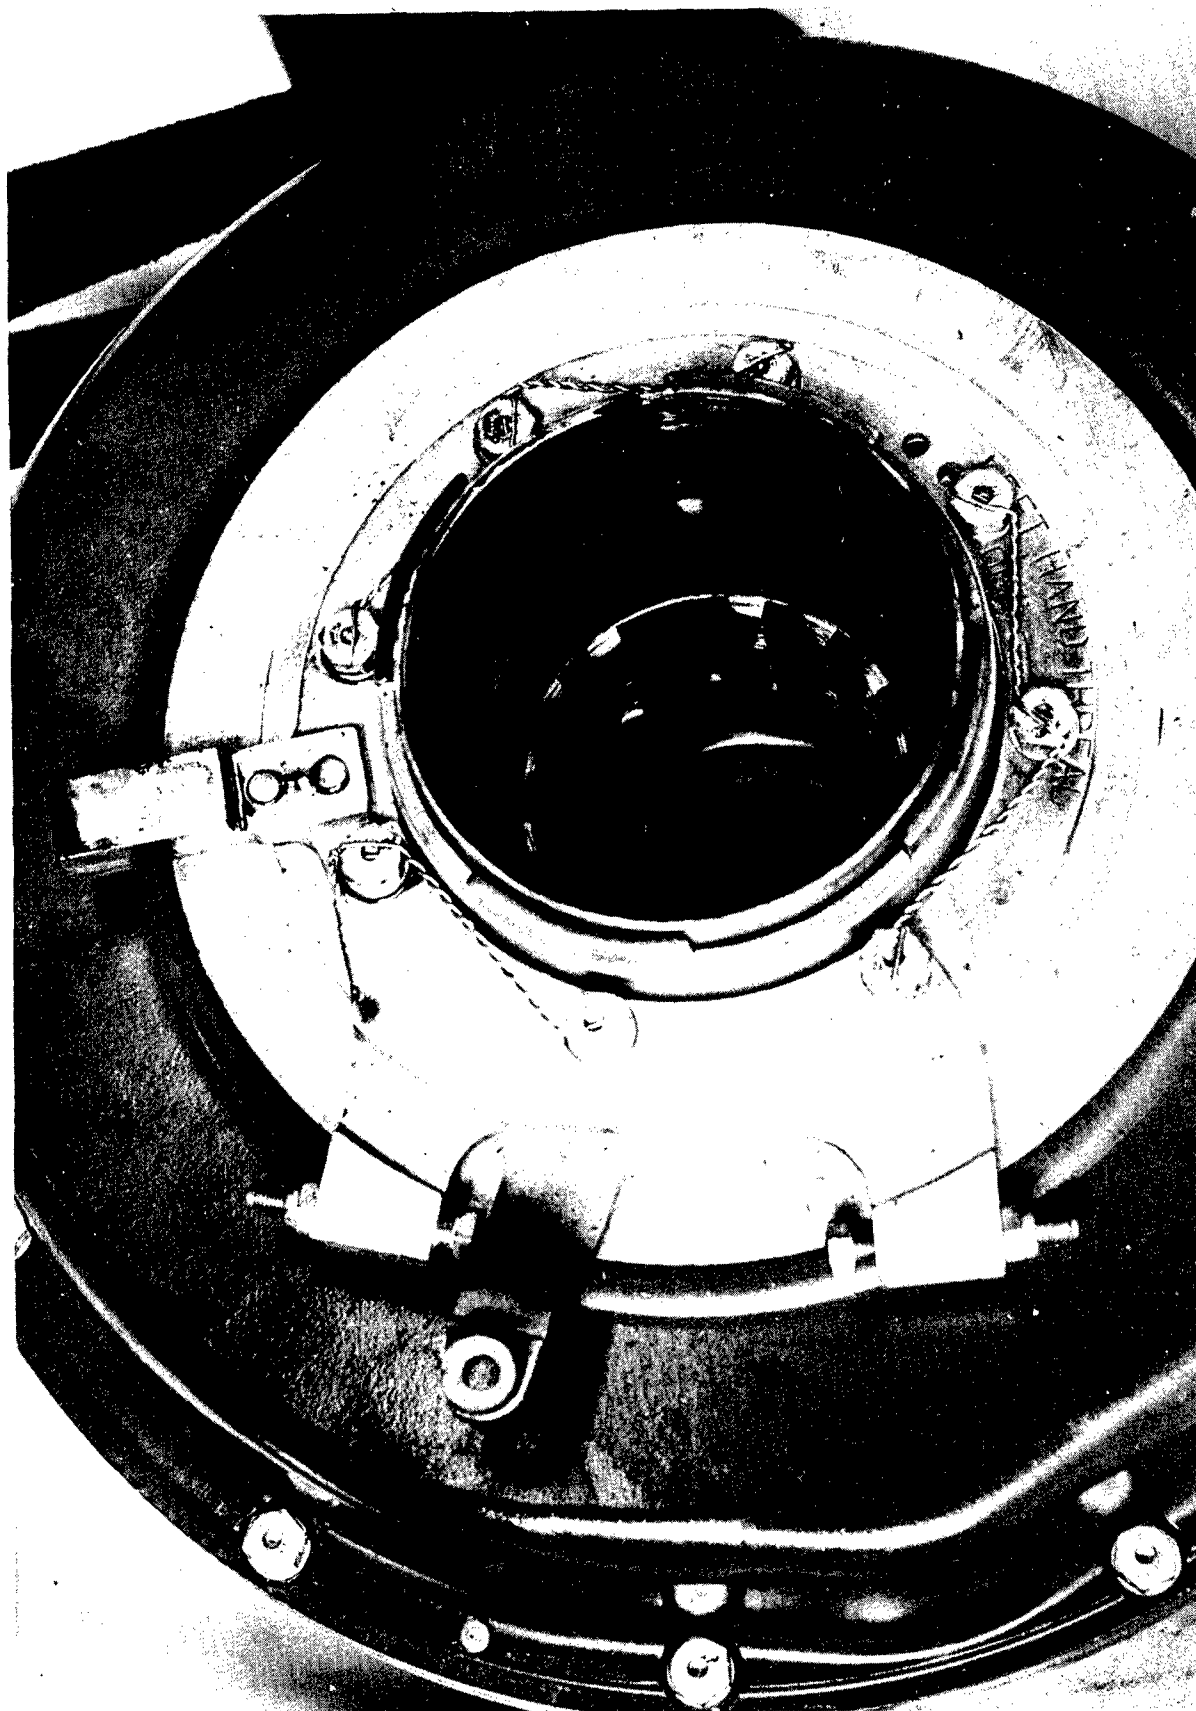
Fig 20 - Inside Face of Hub Rear Cone Seat. A422-69
Propeller on R-1300-1 Engine After 46:30 Hours
of Operation.

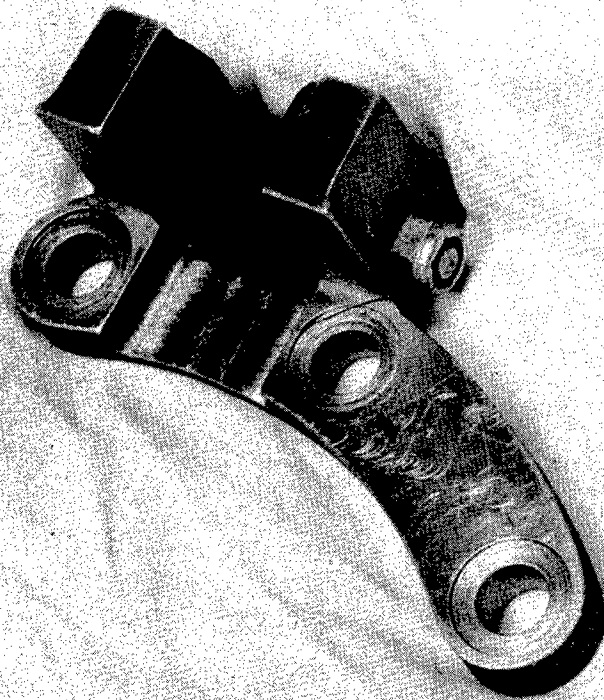
The engine test was intended to be a 25 hour test, but was stopped after 24-1/4 hours due to a failure of the adapter stop as shown in Figure 21. This time was considered satisfactory since there was no shift in the bonding or balance cups.

Fig 21 - Broken Adapter Stop From Aeroproducts A422-69
Propeller After 170:40 Hours on R-1300-1 Engine
in Torque Stand.

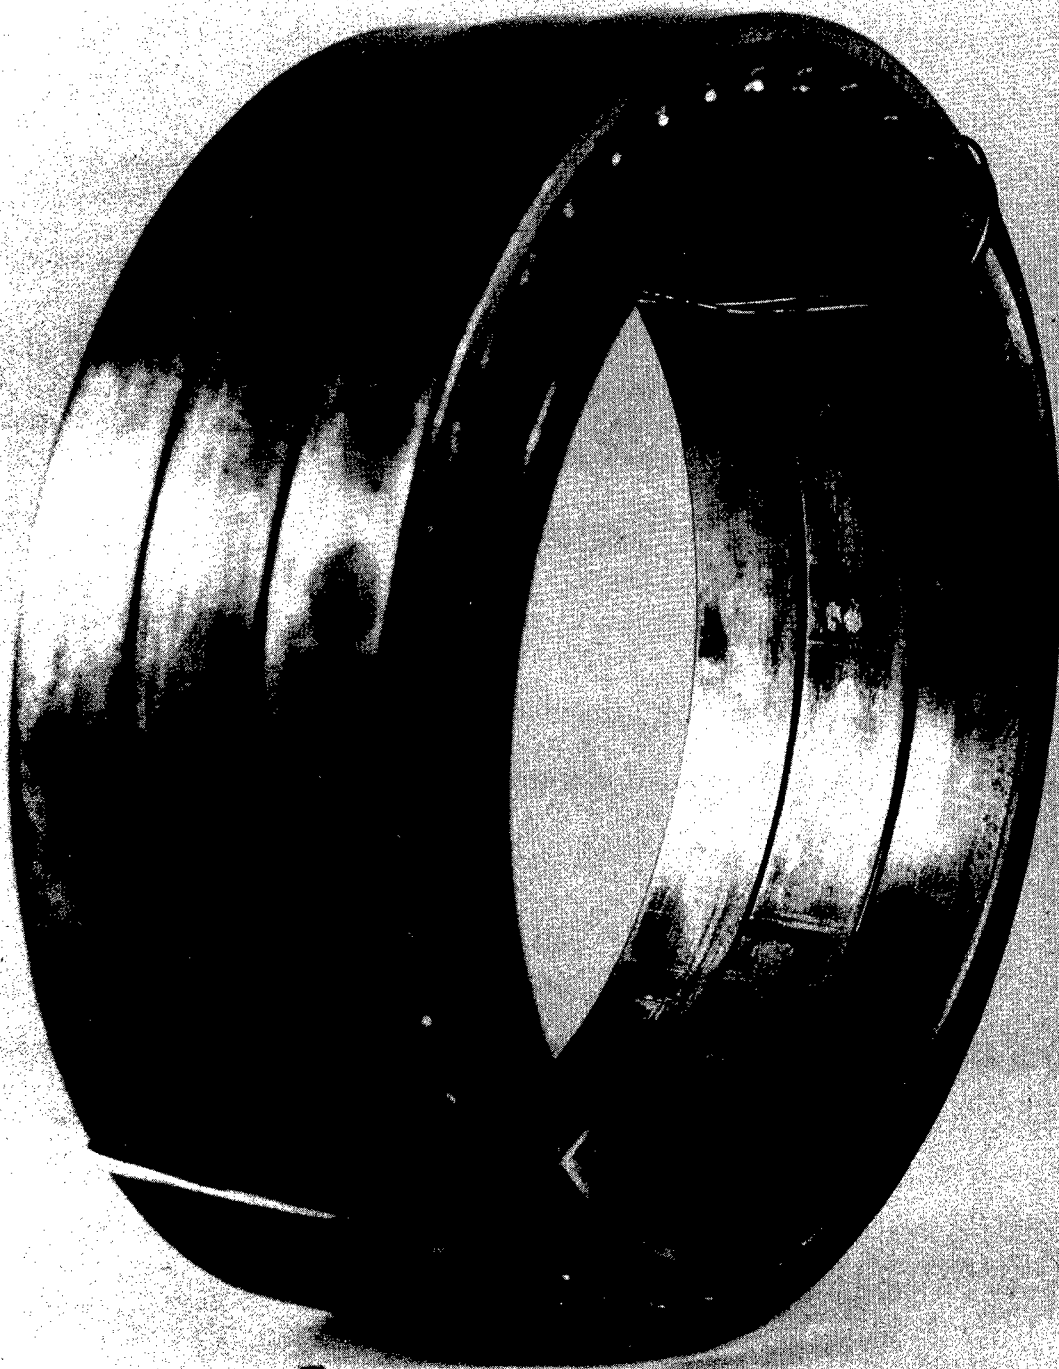
An inspection of the propeller after test revealed that the blade retention bearings were galled slightly as shown in Figures Nos. 22, 23, and 24. However, since this galling was not worse than other cases noted in service, it was felt that there was no necessity for change or for further testing.

Fig 22 - Side View Galled Blade Bearings. Aeroproducts A422-69
Propeller After 170:40 Hours on R-1300-1 Engine in
Torque Stand.

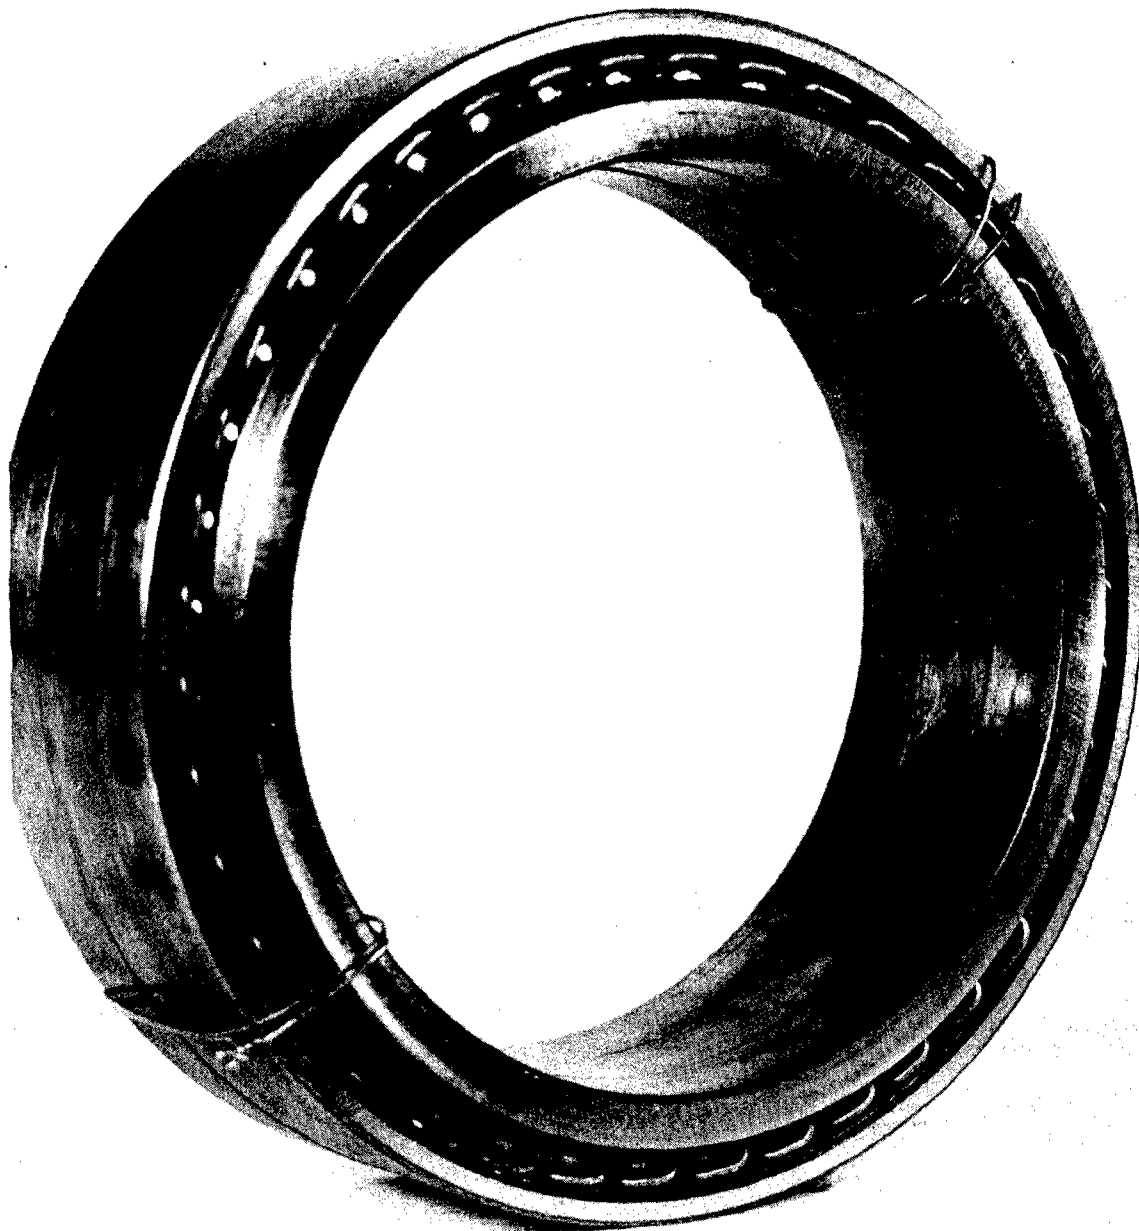
Fig 23 - Front View Galled Blade Bearings. Aeroproducts A422-69
Propeller After 170:40 Hours on R-1300-1 Engine in
Torque Stand.

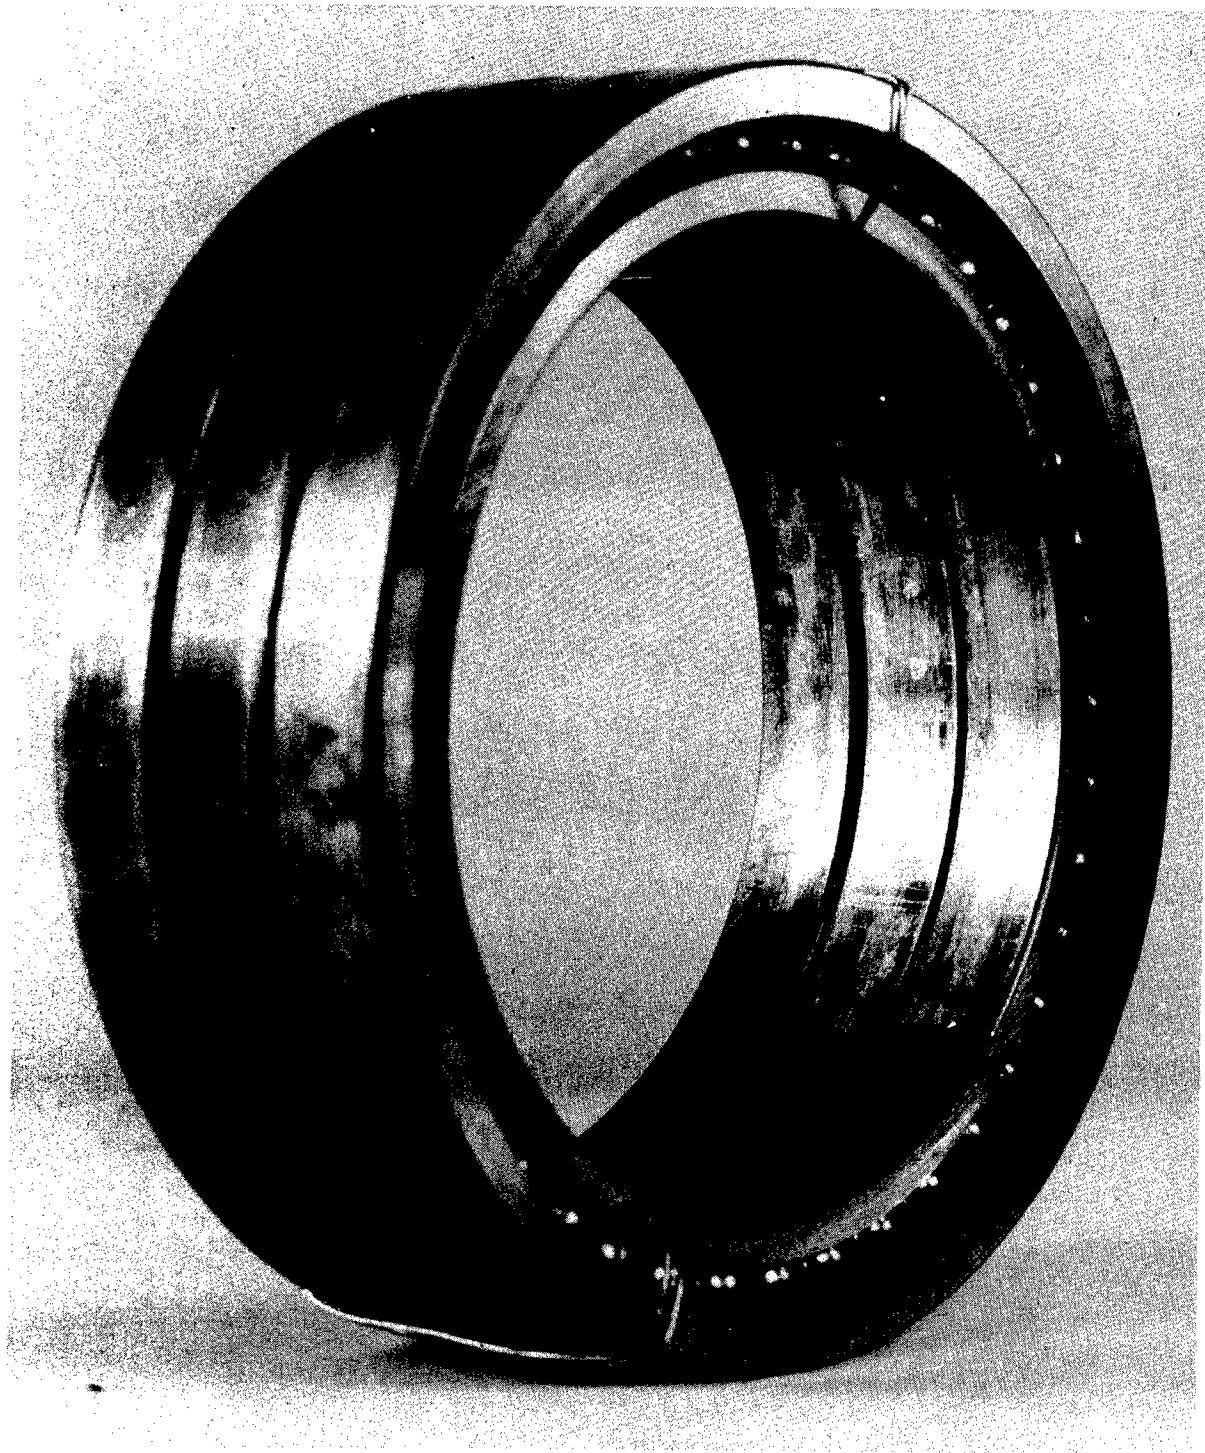
Fig 24 - Back View, Galled Blade Bearings. Aeroproducts A422-69
Propeller After 170:40 Hours on R-1300-1 Engine in
Torque Stand.
